PROGRESSIVE ROOF COLLAPSE DUE TO CLR SHIFTING

BY DAVID R. BOHNHOFF, PHD, PE

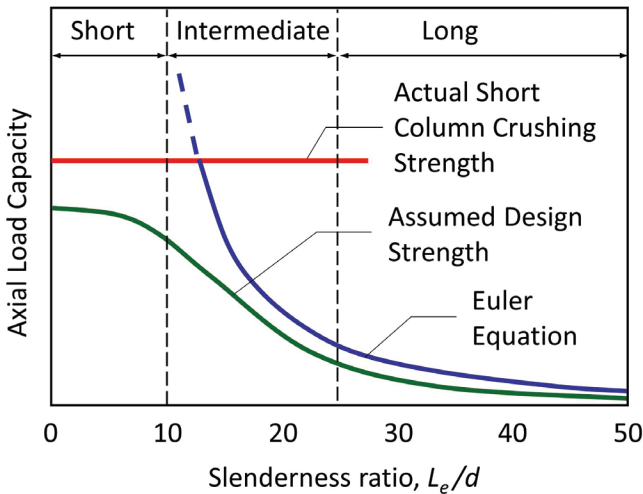
Figure 3. Typical categorization of columns based on mode of failure

Figure 3 shows a typical relationship between the slenderness ratio (L_e/d) of a component subjected to compression (also known as a column) and the component's mode of failure. In this plot, a short column is one that fails via crushing of wood fibers across the component's entire cross-section. A long column is one that fails because of buckling and hence behaves in accordance with Euler's equation. Between long and short columns are intermediate ones whose exact failure mode is less certain.

As illustrated in Figure 3, the amount of axial compressive load that can be applied to a member is increased by reducing the slenderness ratio L_e/d . By adding T-, L-, U-, I- or scab reinforcement along a web member, the designer is effectively turning a long column into an intermediate or short column by increasing d (as opposed to decreasing L_e with the addition of CLR). This same approach is commonly used to eliminate the need for CLR on interior posts. That is, interior post dimensions are made large enough (see **Figure 12**) so that the need for continuous lateral restraint is eliminated.

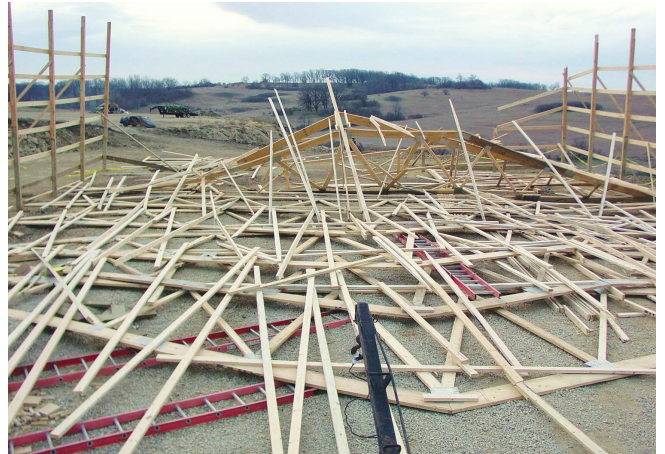
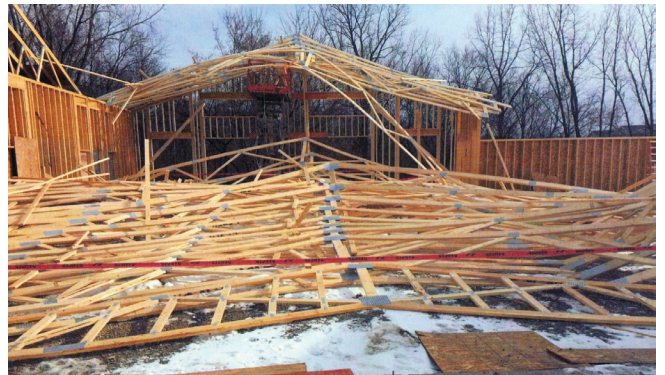
Figure 9. Progressive roof collapses during construction are due to the lack of temporary diagonal bracing on top chord CLR. The bottom image is of a conventional stick-frame building with 2-foot on-center trusses.

The diagonal braces shown in **Figure 8** are generally temporary—their function being replaced by nailed- or screwed-down roof sheathing. Where this is the case, it is important that the diagonal braces *not* be removed until a portion of the nailed- or screwed-down sheathing has been installed. This is especially true for larger buildings because the probability of failure without truss chord or rafter CLR bracing increases exponentially with an increase in the distance the trusses must clearspan, or span without immediate support (Bohnhoff, 2003). Practitioners who transition from residential to post-frame building construction are often not aware of this and thus ignore the need for diagonal bracing in the plane of the roof during construction. This results in job sites like those shown in **Figure 9**.

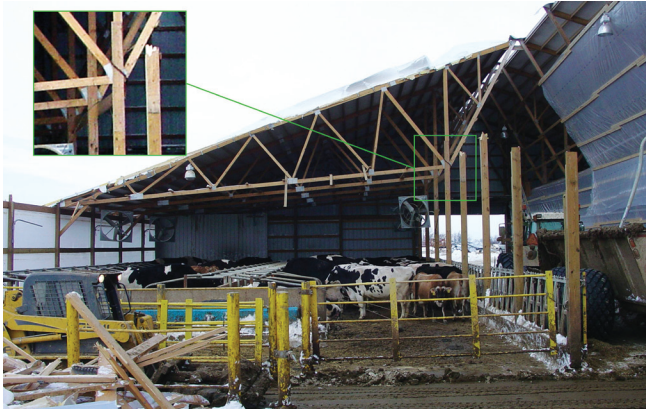
Figure 10. This progressive roof collapse was due to shifting of post-to-truss connection CLR. The chain in the lower image, which is also visible in the inset image, was used to pull the remaining post-to-truss connections back to their original positions.

Figure 10 contains images of a progressive roof collapse that occurred when the CLR on a series of post-to-truss connections

was allowed to shift. This particular collapse occurred in two stages, with the second collapse injuring workers who were trying to remove animals after the first collapse. To prevent further bays from collapsing, a chain and come-along were used to pull remaining post-to-truss connections back to their original positions.

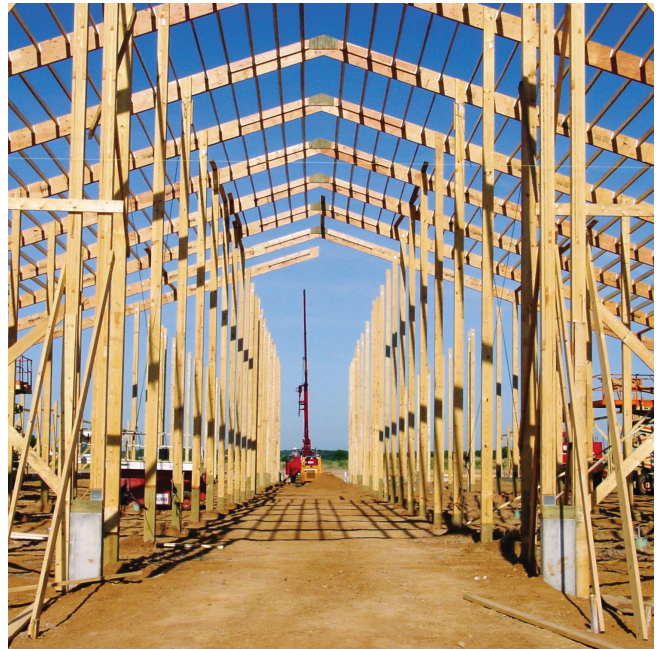
Figure 12. The lengthy interior posts being installed in this photo were five-ply glulam assemblies that did not require CLR to withstand design loads.

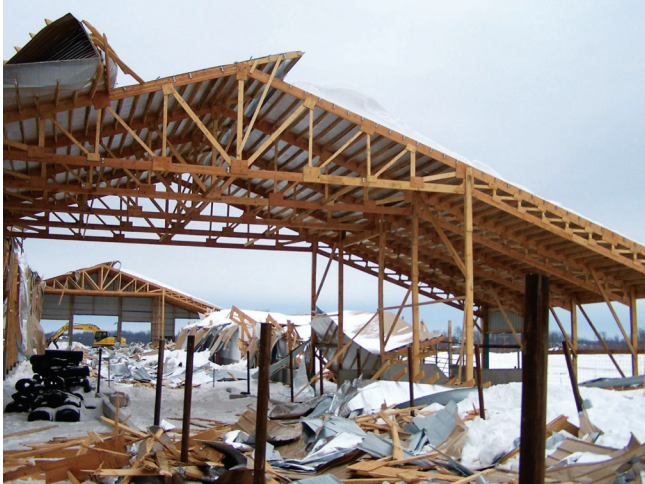
Figure 13. A building with roof sections that would probably not have collapsed if the interior posts had been increased in size and/or supported with additional rows of CLR

Figure 13 contains photos of a non-engineered building with roof sections that collapsed when several interior posts buckled. The interior posts were substantially undersized, given that they were supported by only a single row of CLR. The lower

image in Figure 13 shows the significant curvature of one of the interior posts that did not fail. The point of contraflexure in this post is at the single CLR attachment point. In this particular case, the CLR was kept from shifting with a pair of diagonal braces.
