# YOUR BUILDING IS UNDER SIEGE!!!!

## UNDERSTAND THE FORCES AT WORK TO IMPROVE BUILDING DESIGN AND PERFORMANCE

David R. Bohnhoff, P.E.  
Emeritus Professor  
University of Wisconsin-Madison

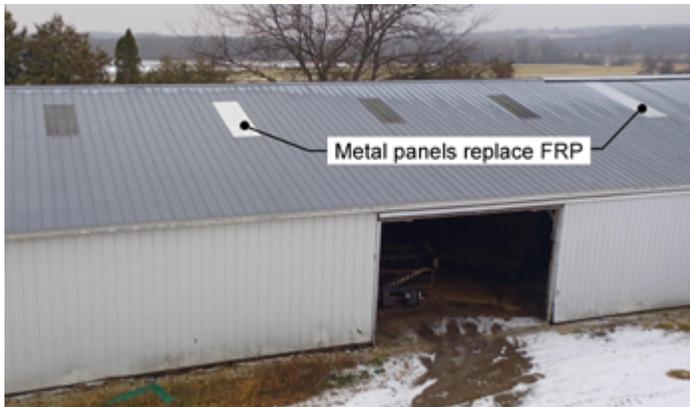
Figure 1 shows the roof of a building constructed in the mid 1960’s. Several original fiber reinforced plastic (FRP) skylights were replaced with new FRP panels around 2007. Since that time the remainder of the original FRP panels succumbed to photodegradation leaving large holes in the roof. In 2022, the owner’s insurance company refused to extend insurance on the building until the holes were properly covered. The owner met this demand using the white steel panels shown in figure 1.

**FIGURE 1. REPLACEMENT OF DETERIORATED FRP PANELS WITH WHITE CORRUGATED STEEL PANELS.**

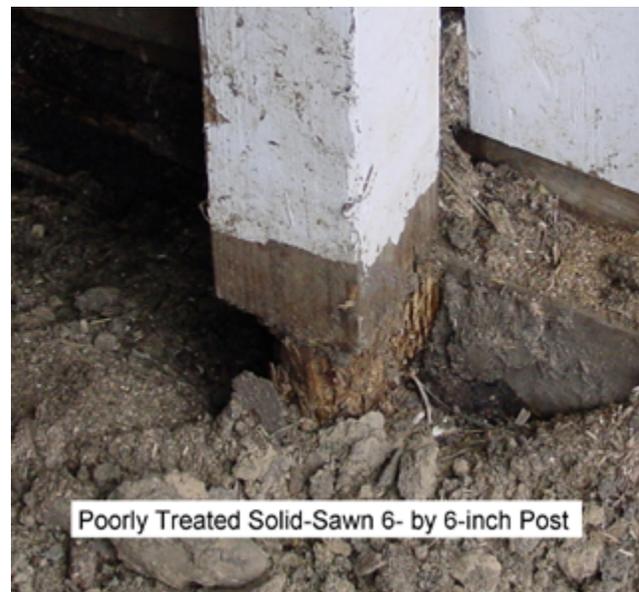
**FIGURE 2. SEVERE WOOD DECAY.**

Wood decay in existing structures is generally the result of (1) poor preservative treatment in a wet environment (Figure 2), or (2) water in contact with non-preservative-treated wood at a location where evaporation of the water is limited. The latter is generally the case when water gets drawn by capillary action into tight interfaces between components where there is little to no airflow. Concrete and masonry products can transmit and hold moisture at fairly high levels so wood that is not properly treated with preservative must be isolated from any concrete and/or masonry that is (1) on the building exterior, (2) not isolated from soil, (3) is routinely washed, or (4) otherwise exposed to water. Isolation is normally accomplished by placing a rigid plastic barrier between the wood and concrete/masonry (Figure 3). Where a wood support post is bearing on concrete in an exterior application, place polyurethane construction adhesive (e.g., Loctite PL Premium) between the wood post and concrete so that it squeezes out as the post is set in place. The adhesive will bond to the wood and concrete, and prevent precipitation from getting drawn (by capillary action) into the tight interface between the components. Ongoing research (Figure 4) has shown this to be very effective in preventing the decay commonly found at the base of wood posts bearing directly on exterior concrete.

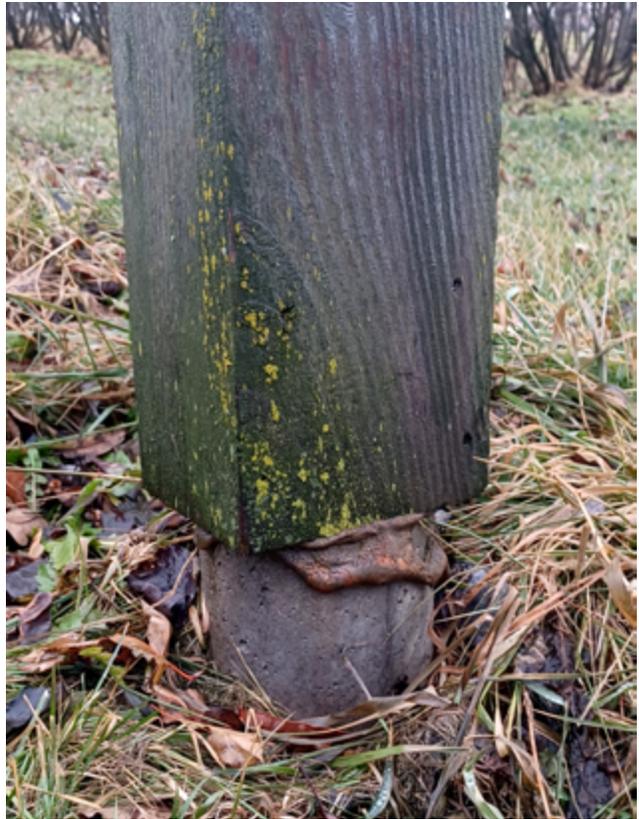
**FIGURE 4. POLYURETHANE CONSTRUCTION ADHESIVE USED TO PREVENT PRECIPITATION FROM GETTING DRAWN INTO THE INTERFACE BETWEEN AN UNTREATED WOOD POST AND A CONCRETE PIPE PIER. THIS CONNECTION IS ONE OF SEVERAL SIMILAR CONNECTIONS MADE IN MAY, 2011 AS PART OF AN ONGOING RESEARCH PROJECT BEING CONDUCTED BY THIS AUTHOR ON WOOD DECAY PREVENTION. AN EXAMINATION OF THIS POST DURING JANUARY, 2023 (WHEN THIS PICTURE WAS TAKEN) DID NOT REVEAL WOOD DECAY. NOTE THAT THIS CONNECTION IS LOCATED IN A HEAVILY SHADED AREA.**

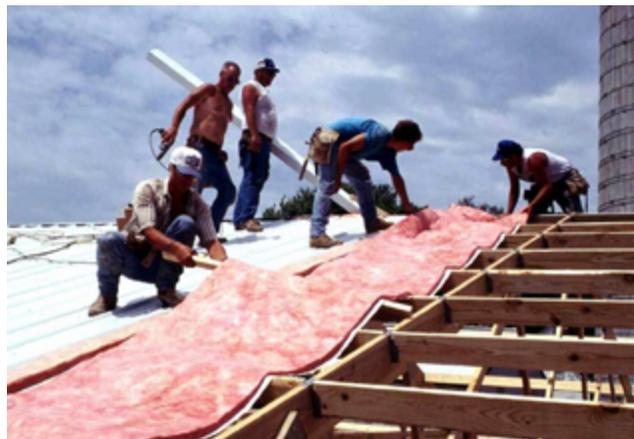
**FIGURE 7. INSTALLATION OF VINYL-FACED FIBERGLASS INSULATION BETWEEN WOOD FRAMING AND CORRUGATED METAL ROOFING.**

Condensation in animal confinement buildings is often reduced by installing faced fiberglass (Figure 7) or rigid board insulation directly under the roof cladding, or by spraying foam insulation against the underside of the cladding. To function properly (and not cause more problems than they solve), these insulations must be properly installed and maintained. Insulations have the added effect of reducing radiant heat gain during hot and sunny weather and reducing heat loss during cold weather. Interior dripping due to condensation can be reduced by adhering anti-drip liners to the underside of roof sheathing. These liners hold condensation until it can re-evaporate into interior air.

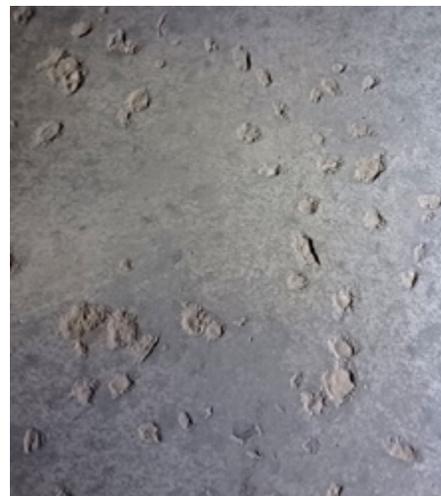
**FIGURE 8.**  
**OVER-FINISHED**  
**AIR-ENTRAINED**  
**CONCRETE**  
**AFTER ONE**  
**YEAR OF WINTER**  
**EXPOSURE.**

Buildings in cold climates are subjected to freeze-thaw cycles that can deteriorate concrete, masonry products, and mortars. This deterioration is significantly reduced with proper air entrainment and surface sealing to limit intrusion of moisture. Be aware that ordering properly air-entrained concrete will not result in improved freeze-thaw resistance unless the concrete is properly placed. Figure 8 shows a concrete surface one year after placement. Although this concrete had a very low water/cement ratio and was ordered with 6% air entrainment, it was over-worked after placement

(i.e., excessively power-floated and power-troweled) which removed surface air entrainment.

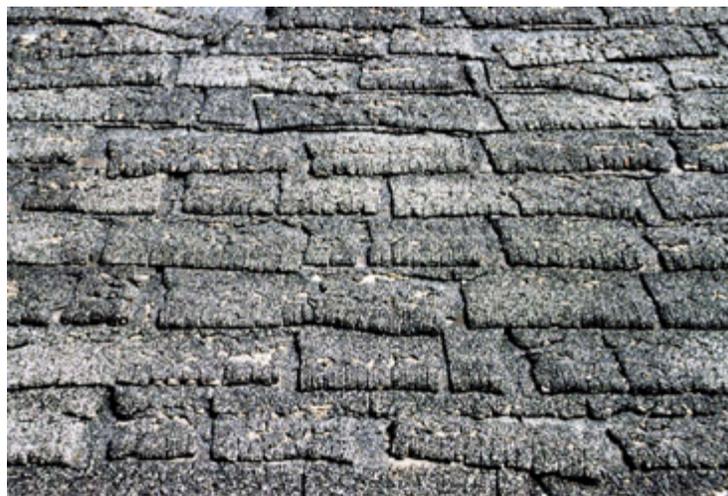
**FIGURE 9. BADLY DETERIORATED BLACK ASPHALT SHINGLE ROOF AFTER ONLY 20 YEARS OF SERVICE.**

Figure 9 shows an asphalt shingled roof 20 years after original installation. This was a black roof and hence frequently subjected to extreme temperature swings. The resulting expansion and contraction produced the cracking shown. It is important to note that cracking exposes asphalt below the granular surface making it much more susceptible to photodegradation.

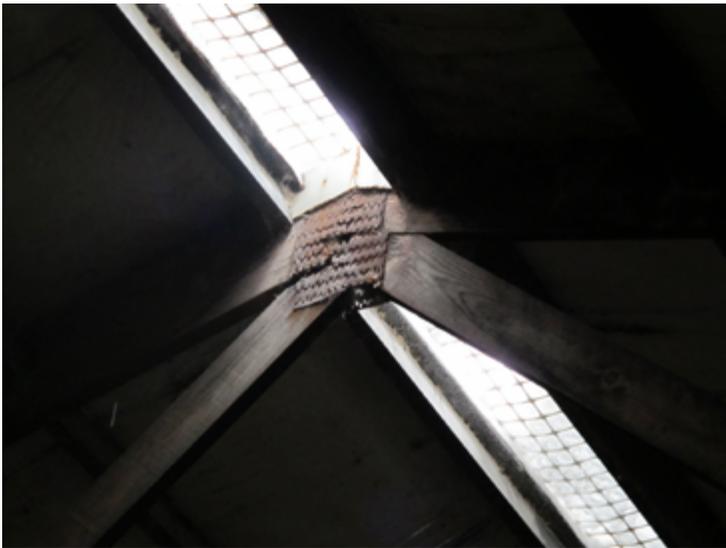
**FIGURE 10. CORRODED METAL TRUSS PLATE UNDER AN OPEN RIDGE IN A DAIRY FREESTALL BARN.**

truss plates at the ridge of animal confinement buildings. Not only are the plates subjected to repeated moisture cycling and extreme temperature swings, but they are also exposed to the corrosive effects of manure gases (i.e., hydrogen sulfide (H<sub>2</sub>S) and ammonia (NH<sub>3</sub>)) as they vent out of the facility. Figure 10 shows metal connector plate deterioration at a building ridge. Many designers avoid this problem by using engineered lumber rafters in place of metal-plate-connected trusses.
