The Impact of Corrosion on Fire Department Vehicle Fleets

An applied research project for the Ohio Fire Executive Program

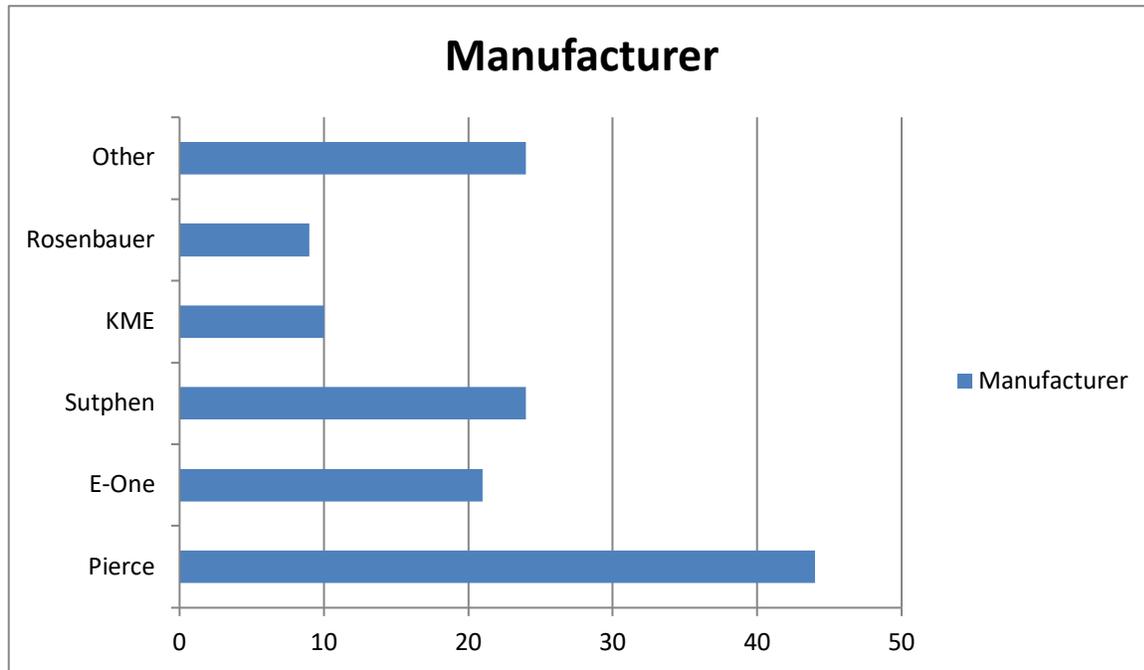
Figure 1

Apparatus manufacturers were varied as illustrated in Figure one.

Apparatus owned by departments surveyed by manufacturer

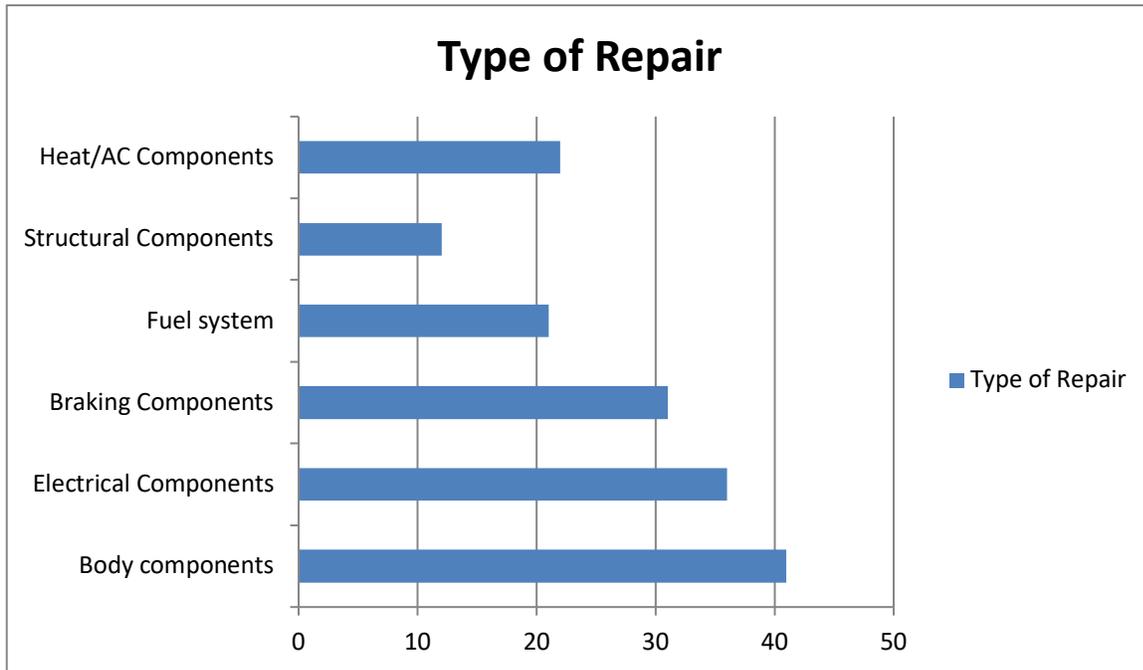
Figure 2

The types of issues most commonly encountered affected body components (exterior body panels, grab handles, door latches, etc.), electrical components, and braking components. Figure two illustrates the number of respondents that reported three or more repairs in each category in the last three years.

Frequency of repairs in fire apparatus by type of repair

Though structural components had the lowest reported amount of repairs, 27.8% of respondents reported retiring a vehicle from service prior to its anticipated service life due to corrosion. An additional 8.3% reported corrosion may have played a role in prematurely retiring a vehicle from service. The departments surveyed in areas where snow and ice control materials were not routinely used had a significantly lower frequency of corrosion related repairs, and none of them reported premature retirement of apparatus due to corrosion.

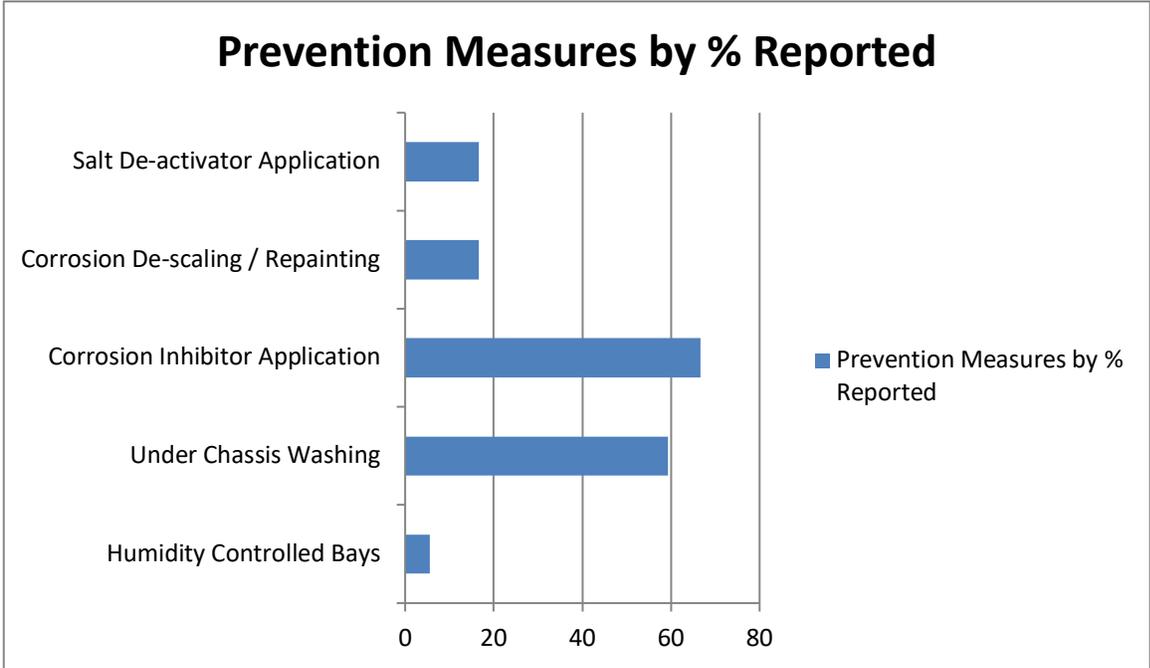
Figure 3

In addition to keeping vehicles washed, several other prevention measures were reported. Figure three illustrates the types of preventive measures that were reported.

Corrosion Prevention Measures by frequency

Periodic application of a corrosion inhibitor such as Fluid Film or Carwell was the most common prevention measure reported. Under-chassis washing was also a common prevention measure. Very few respondents reported doing anything to control the humidity level in vehicle storage areas.

The data was somewhat inconclusive in regards to how effective any prevention measures were as many departments reported both utilization of preventive measures and having to prematurely remove a vehicle from service. Several departments did note in their comments that they had seen a positive impact in reducing corrosion issues once they started applying preventive measures. Some departments also noted that a very positive effect was found when corrosion prevention measures were implemented when the vehicle was new as opposed to treating older vehicles that already had corrosion issues.
